activity 2010

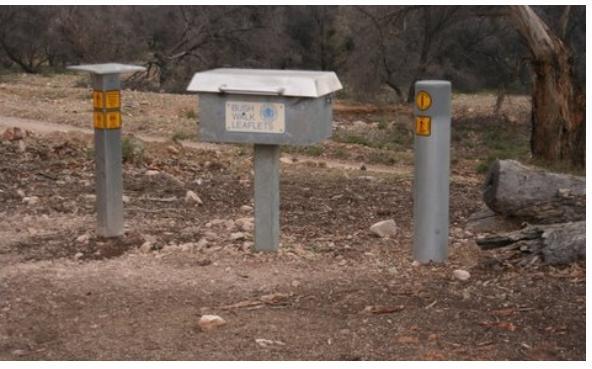
Encouraging the visiting public to walk and enjoy some of the more interesting parts of the Flinders in part depends on availability of good information. WTSG is undertaking the supply and servicing of leaflets at trailheads. Here, Grindell trailhead, a map column, leaflet dispenser and, critical to our capacity to print leaflets, a donation column.

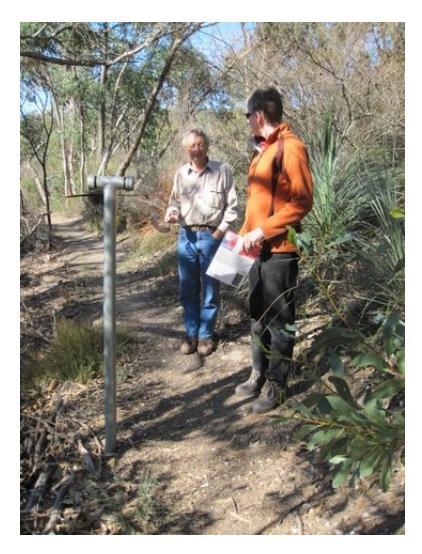
Lies, damned lies and statistics! Pedestrian counters well placed and monitored over time do indicate trends and in the absence of any other technology are a valuable indicator of use. Here a completely self contained *Traker* in Hale Conservation Park records around 1500 walkers per year.

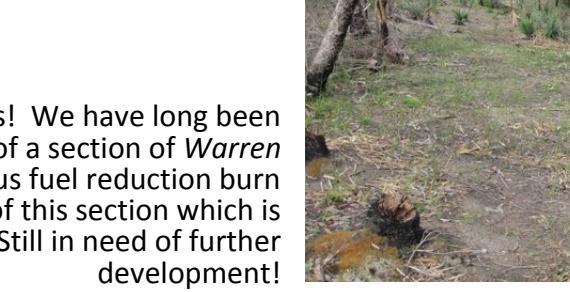
Answer the door when opportunity knocks! We have long been concerned at the progressive degradation of a section of *Warren Tower* beyond checkpoint W3. A vigorous fuel reduction burn opened the way for improved routing of this section which is also portion of the Heysen Trail. Still in need of further development!

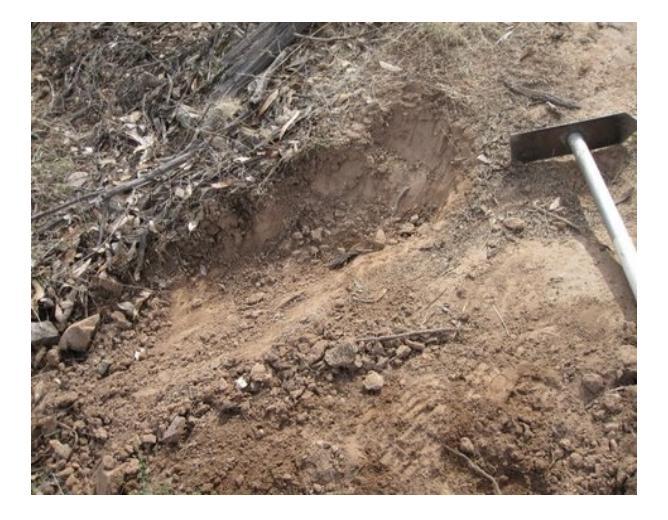
Tracks to traditional destinations have often become degraded through poor original siting and lack of maintenance. While realignment involving control of longitudinal and cross track grades will usually rectify problems sometimes there is a need for interception drains to ensure that the track does not capture natural run-off. An example on the *Dutchman Stern* this year.

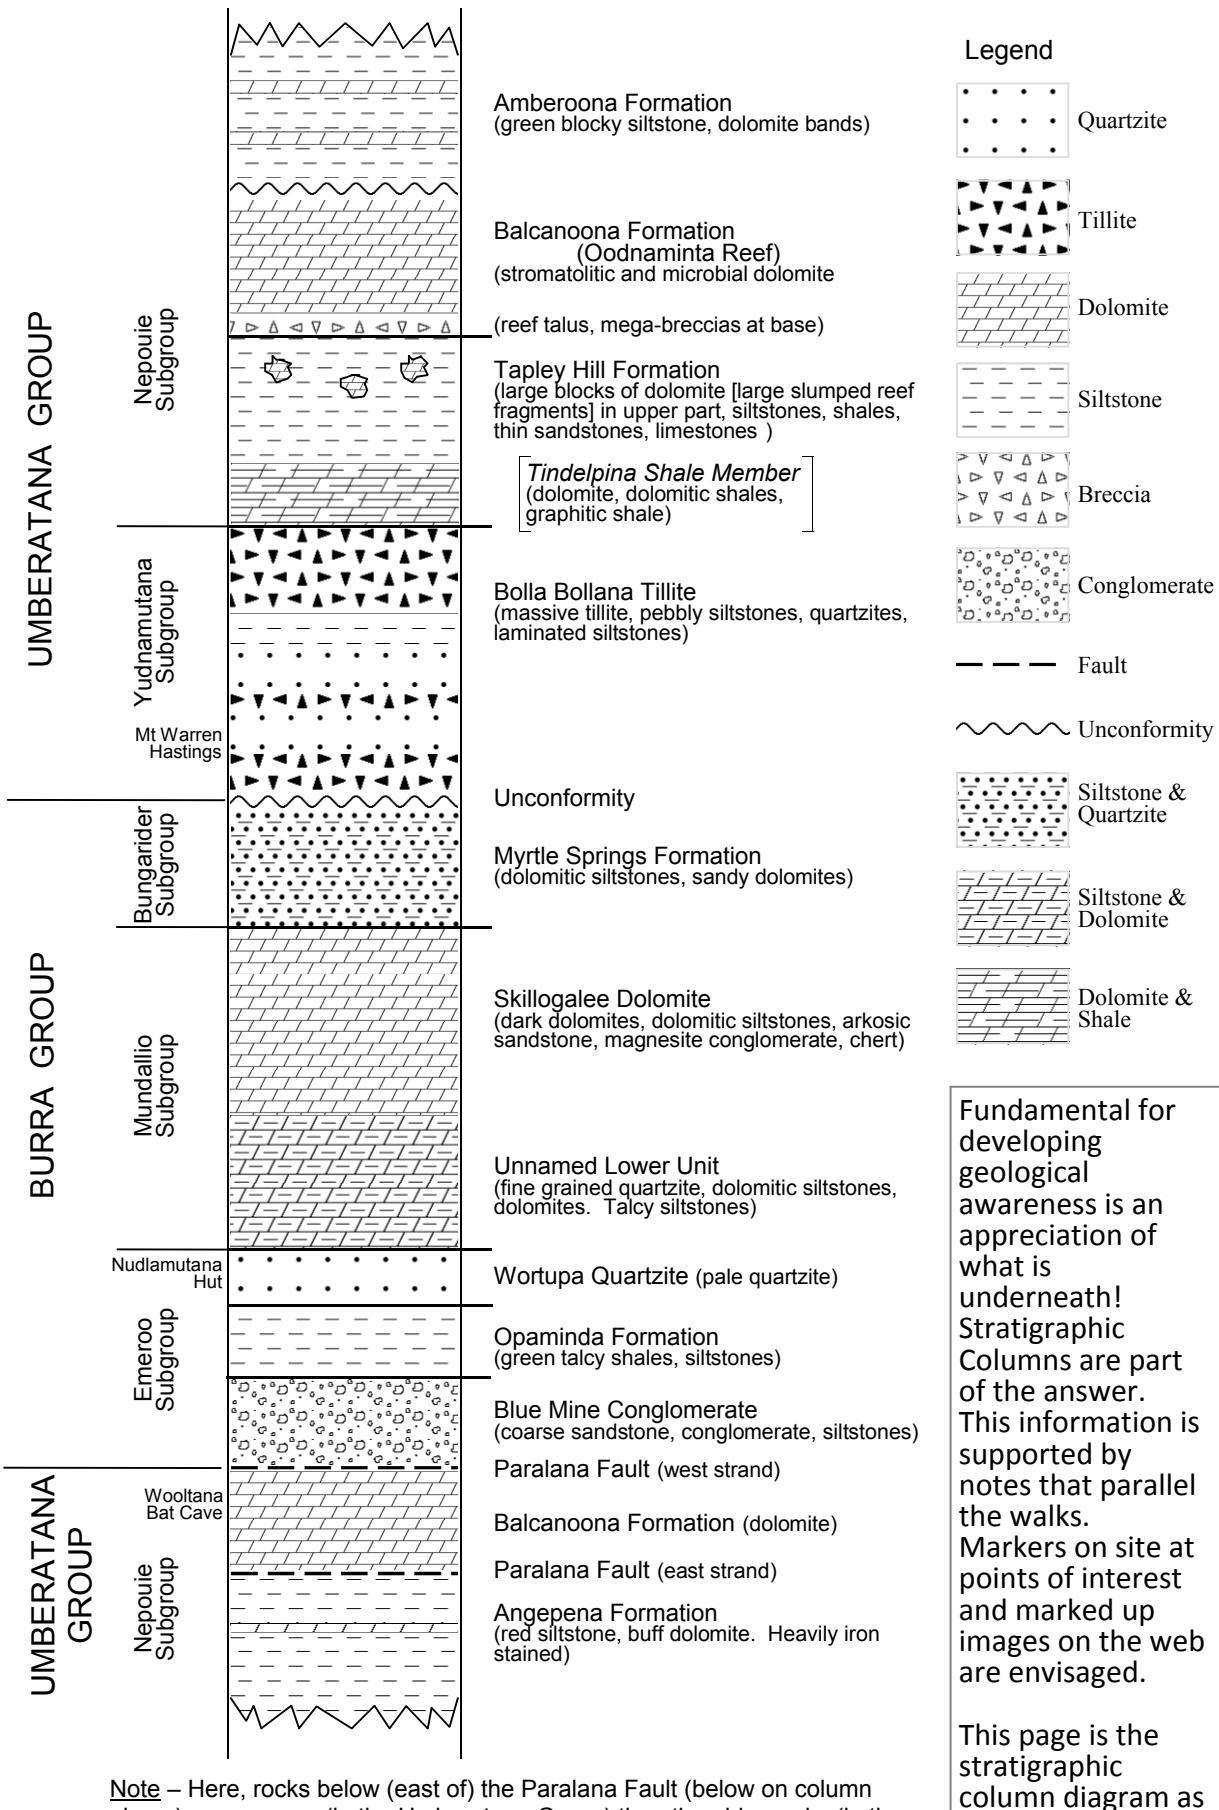
STRATIGRAPHIC COLUMN for OPPAMINDA — NUDLAMUTANA GEOLOGY WALK

<u>Note</u> – Here, rocks below (east of) the Paralana Fault (below on column above) are younger (in the Umberatana Group) than the older rocks (in the Burra Group) which lie (structurally) above them. This is because the rocks west of the Paralana Fault have been pushed, up and over younger rocks, along the fault

Geological guide notes have been added to the Flinders bushwalks information on the website. A sample stratigraphic column for the Oppaminda-Nudlamutana bushwalk is shown on p.3. A geological hammer symbol has been introduced to identify places of geological interest.
